**BUTTE COUNTY**  
**AIR QUALITY MANAGEMENT DISTRICT**  
**INSPECTION REPORT**

<b>NAME OF SOURCE</b>	Paradise Camp Fire Debris Removal		
<b>LOCATION/PHONE:</b>	Paradise		
<b>CONTACT PERSON(S):</b>	Tom Parker	<b>TITLE:</b>	Supervisor, Hazardous Materials Program, Environmental Health Public Health Dept, Butte County
<b>PERMIT NUMBERS:</b>	N/A		
<b>EQUIPMENT:</b>	Various mobile and portable construction equipment		
<b>OPER SCHEDULE:</b>	Variable

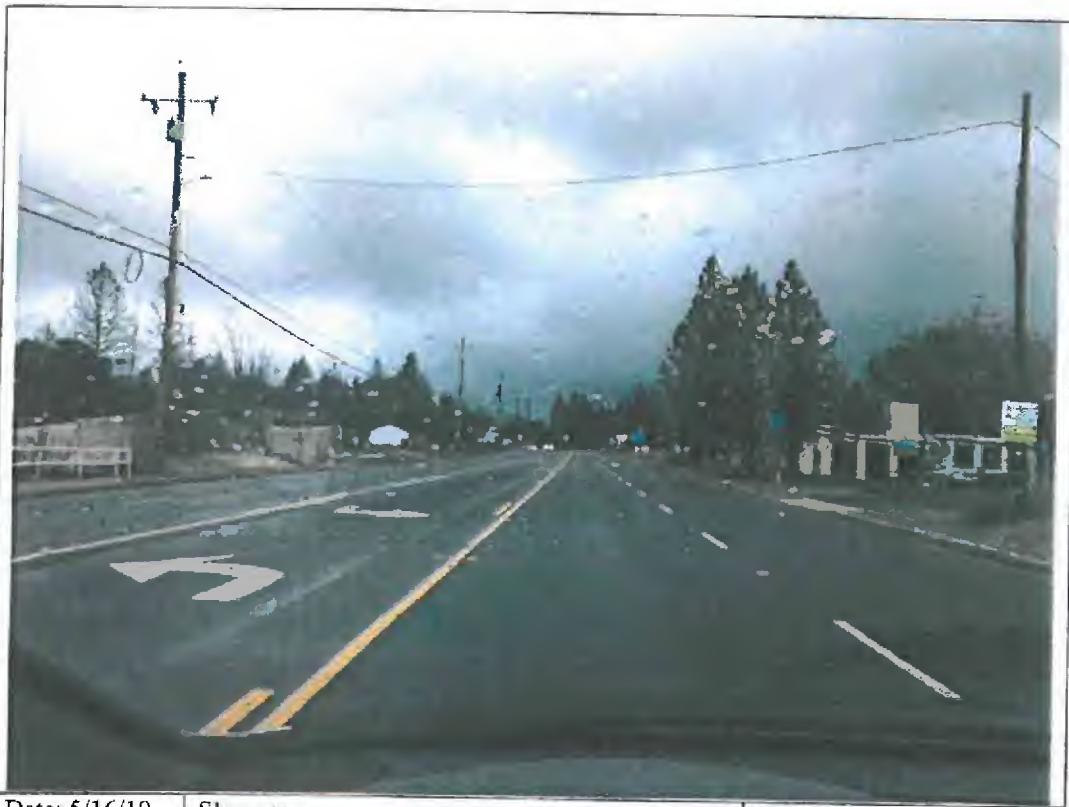
Date: 5/16/19	Skyway	Looking: North
Time :13:19		Photo by: U. Parker
	Permit No: N/A	Photo: 1 of 6

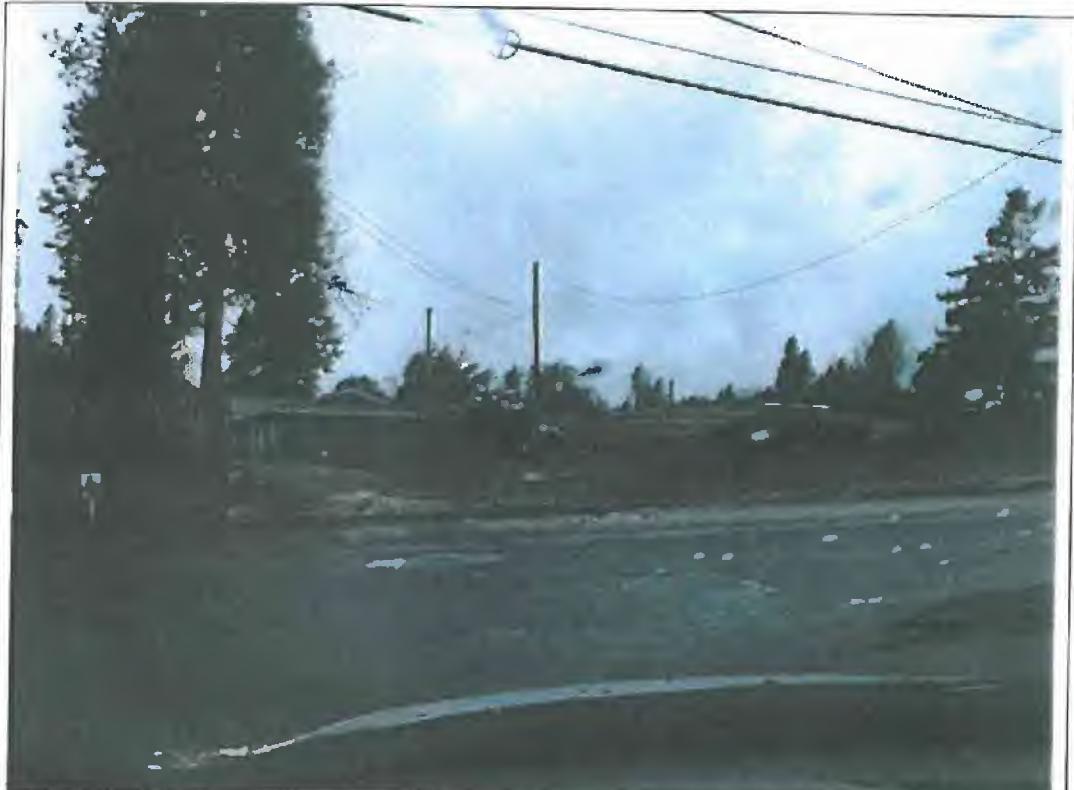
Date: 5/16/19	Across (South) from 1657 Billie Rd., mud on	Looking: South
Time :13:29	Billie Rd – Feather River Construction truck leaving site at time of arrival	Photo by: U. Parker
	Permit No: N/A	Photo: 2 of 6

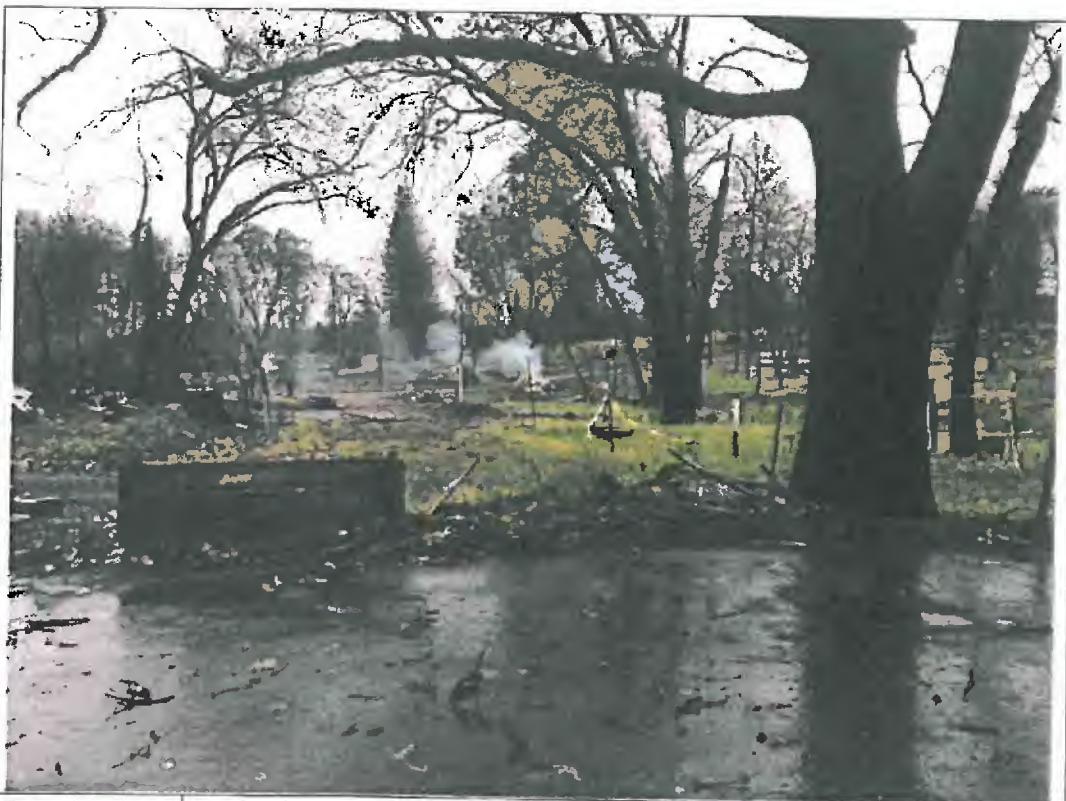
Date: 5/16/19	Pile burning at southeast corner of Billie Rd.	Looking: South
Time :13:32	And Clark Road	Photo by: U. Parker
	Permit No: N/A	Photo: 3 of 6

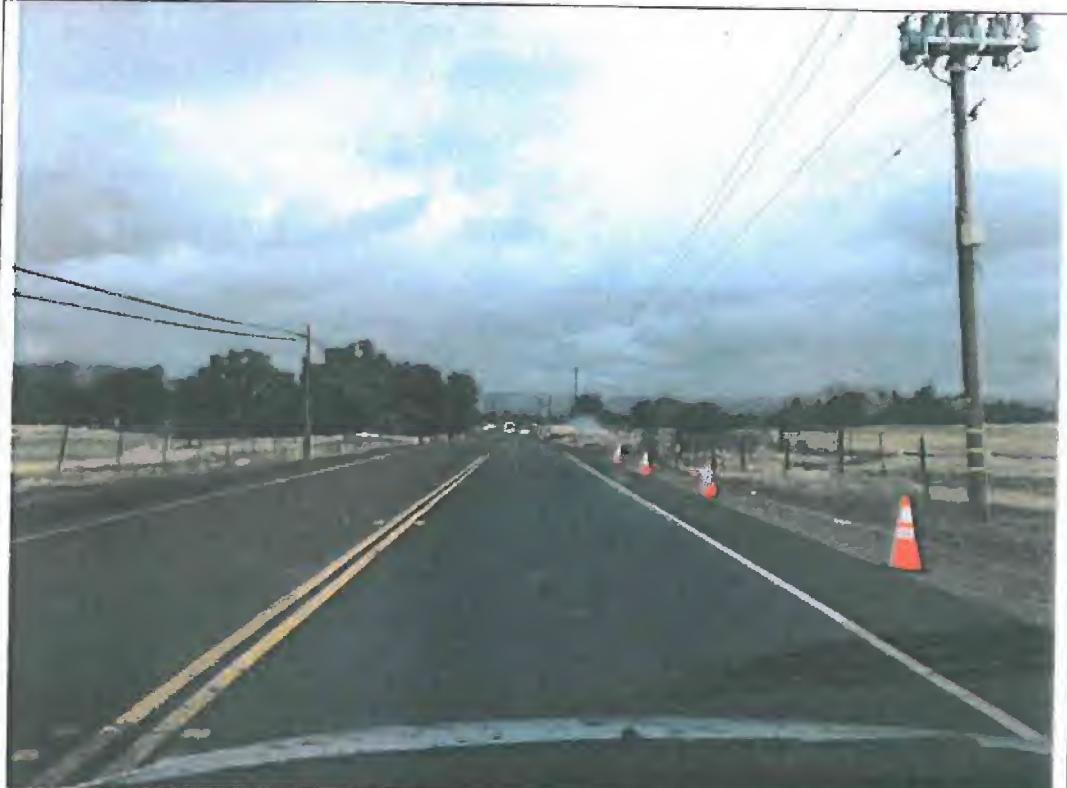
- Photo #6362-6364 – Timber/tree collection area northeast of Durham Pentz Rd and Clark Rd., minimal trackout on roadway, no dust issues. We have received complaints about dust from this facility. Additional gravel at entrance/exit may help with knocking off mud before trucks re-enter roadway.

Date: 5/16/19	Clark Road	Looking: North
Time :13:49	Trackout on roadway from timber holding area northeast of Durham Pentz/Clark Road	Photo by: U. Parker
	Permit No: N/A	Photo: 4 of 6
